Shearographic Non-Destructive Evaluation
of the
Space Shuttle

Christopher K. Davis, NASA
Jeffery A. Hooker, INET
Stephen M. Simmons, INET
Kenneth E. Tenbusch, NASA

John F. Kennedy Space Center, Florida

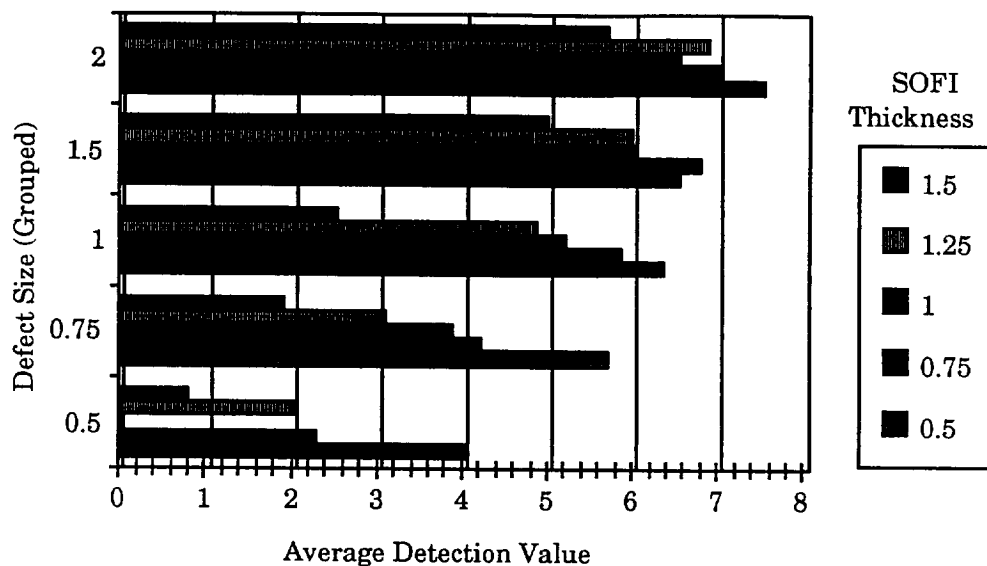
The results of the SOFI testing indicate that debonds with dimensions along the direction of the shearing on the order of the foam thickness were easily detectable and flaws with dimensions on the order of the foam thickness were often detected and a significant number of even smaller defects were observed. The shearing optics in the camera used in testing had a 0.5 degree shearing angle, a limited number of images were taken with 1 degree shearing optics. The 1 degree

camera did not provided any additional detections, but did provide better fringe visibility. Preliminary data showing defect detection as a function of defect size and SOFI thickness are shown below in CHART 1.

CHART 1: Average detection values of debonds in SOFI at a vacuum of 1 inch of water. Values of 4 or greater are detects.
